Industry Case Study

BELDEN
universal

PACKAGING APPLICATION

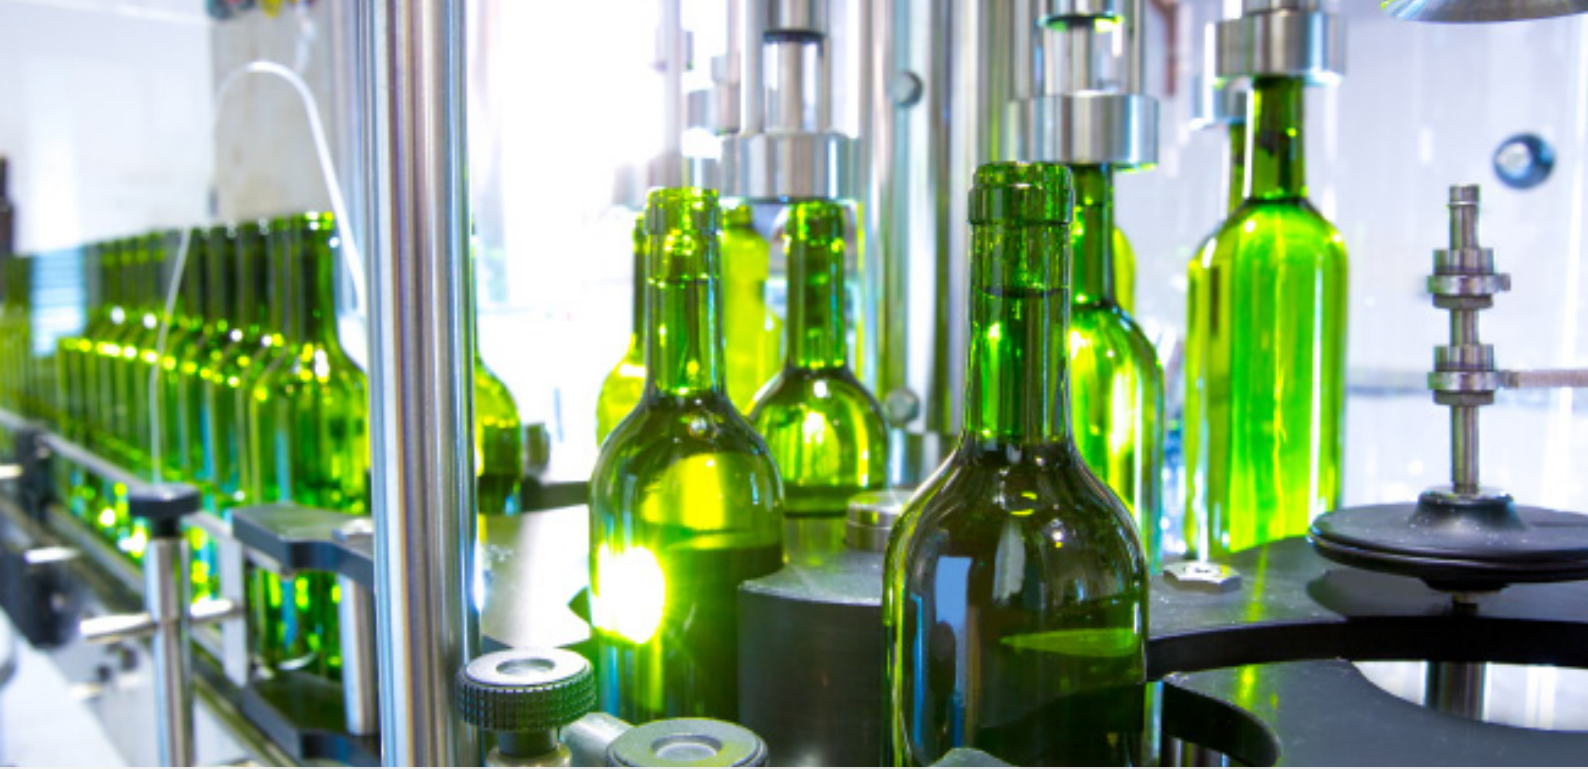
A customer was having a problem with a standard cross and needle bearing universal joint during the wash-down phase on the automation equipment of his food application. The needle bearing joint would absorb the chemical solution used twice daily to clean and sterilize the equipment. Once the alloy bearings absorbed the chemical compounds, gumming would occur causing the joint to run tight, lock up and fail. After discussing operating conditions and product specifications with the customer, Belden Universal developed a precision engineered hybrid of a pin & block needle bearing joint combination made completely out of stainless steel with

composite bushings. The hybrid pin & block needle bearing design employs the higher torque capacity of the friction bearing with the needle bearing's ability to continuously operate at higher speeds with less wear, and even less backlash. The composite bearings can handle harsh abrasives found in the cleaning products used by the customer allowing the joint to operate freely and cycle for a longer duration before any precision is compromised. The Belden Universal solution provided the customer a completely wash-down safe universal joint, eliminating corrosion issues and contamination, burnout, and joint seizure.
